July 27, 1993

RE: SITE INSPECTION TO PAULA PENNOCK'S RESIDENCE AT 735 MERCURY DRIVE

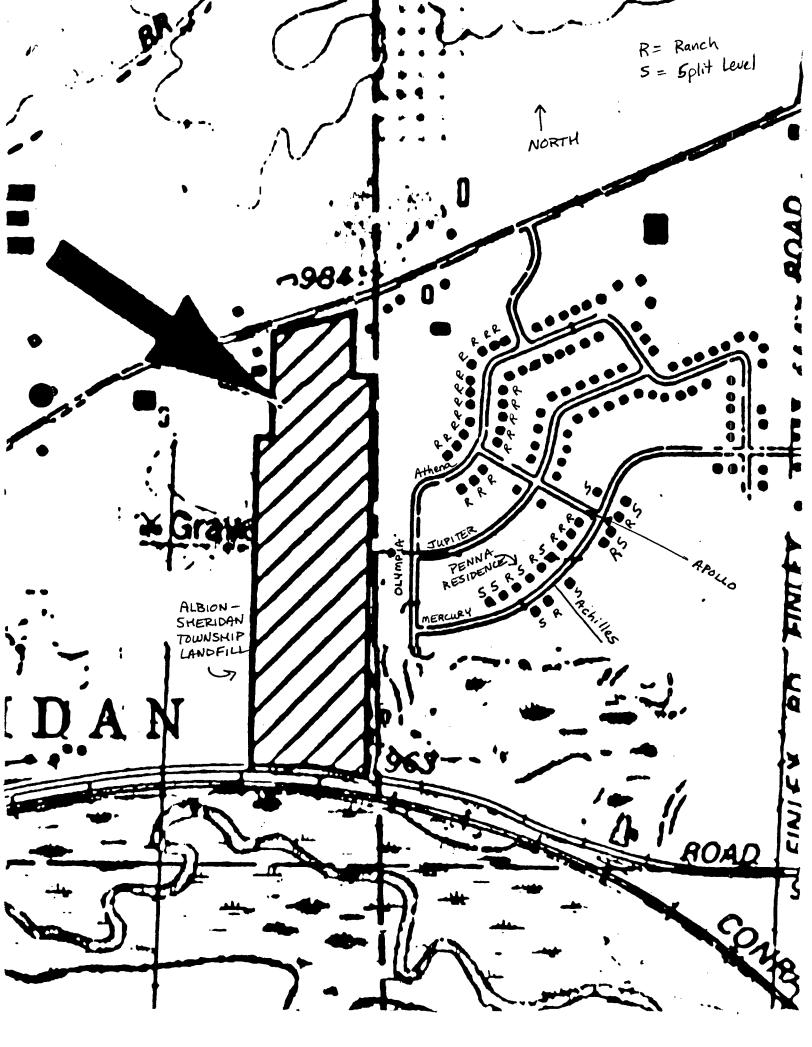
I also drove around the subdivision and noted which houses were split-level and which houses were of the ranch style. With this style of home, it was difficult to assess whether these homes had a basement or whether they were on a concrete slab. That sketch map is also attached.
